Lt. Lehigh Creek - Case Study

- Heavily pastured stream
- Stream bank erosion
- Limited fish cover
- Poor riparian buffer
- Wild brown trout population nearby

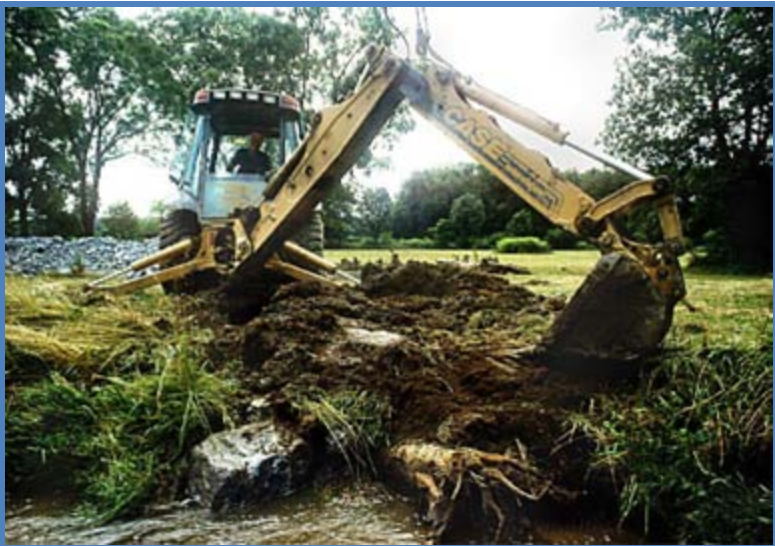
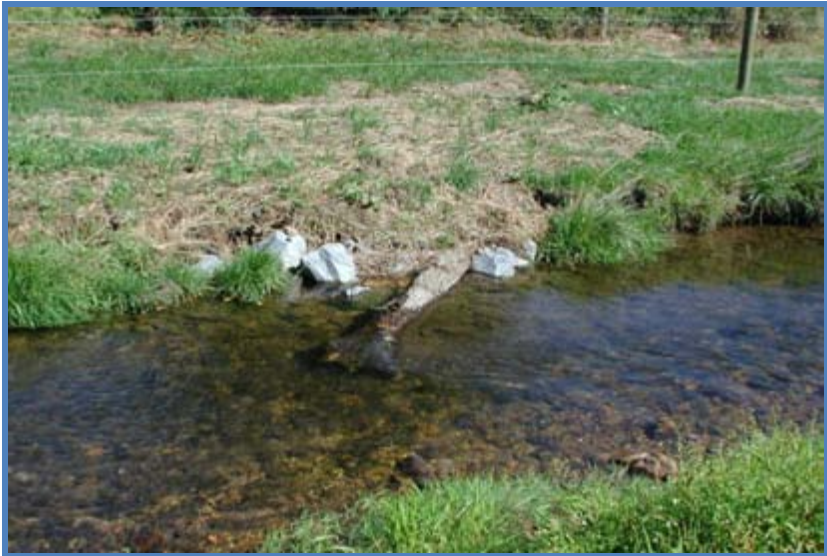
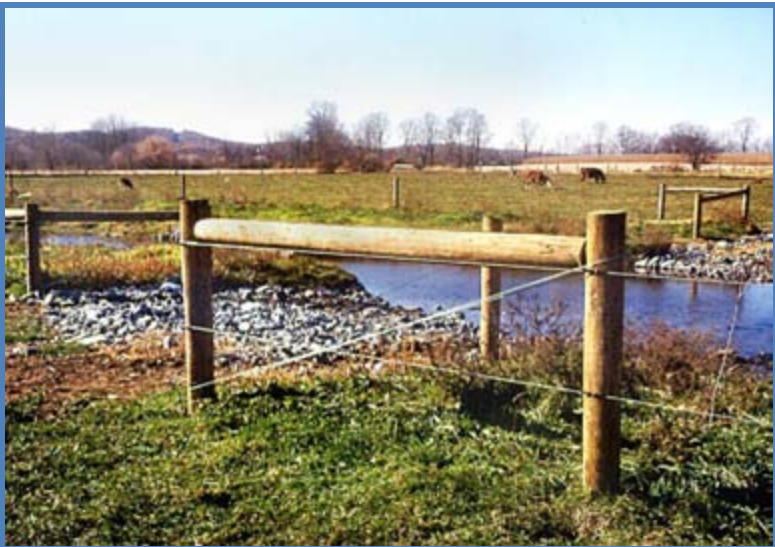
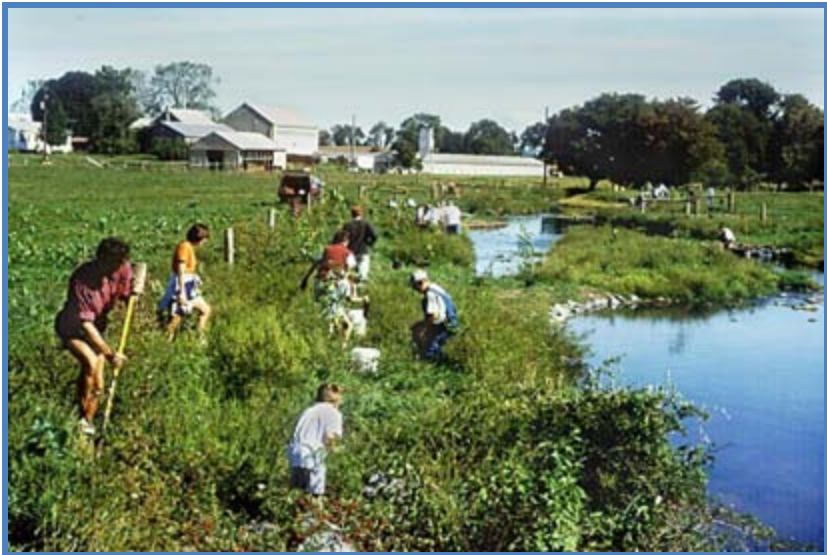
Work included fish habitat/stablization structures.....

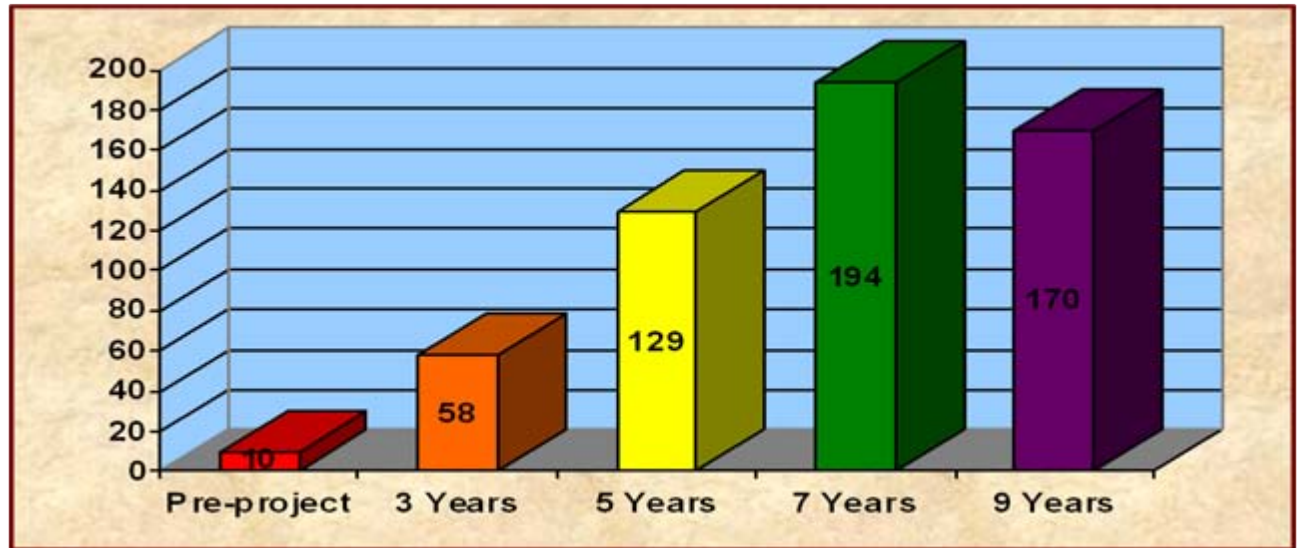
Total Wild Brown Trout

(Sites 1 and 2 Combined)

•Wild brown trout numbers showed a steady increase until leveling out after 7 years.

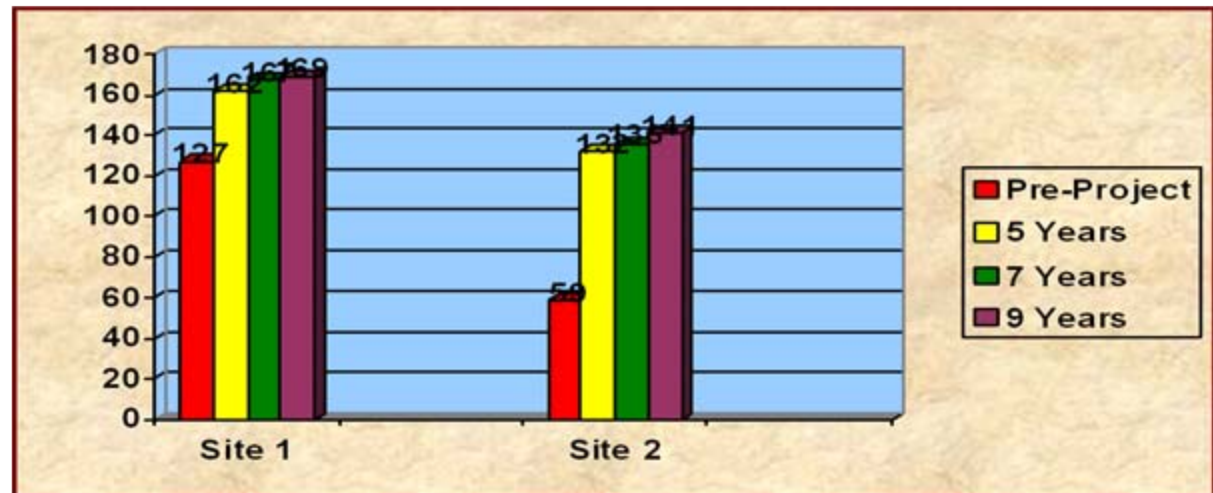
Total Habitat Assessment Score

(Maximum Score =200)

•Physical habitat scores significantly increased after project completion.

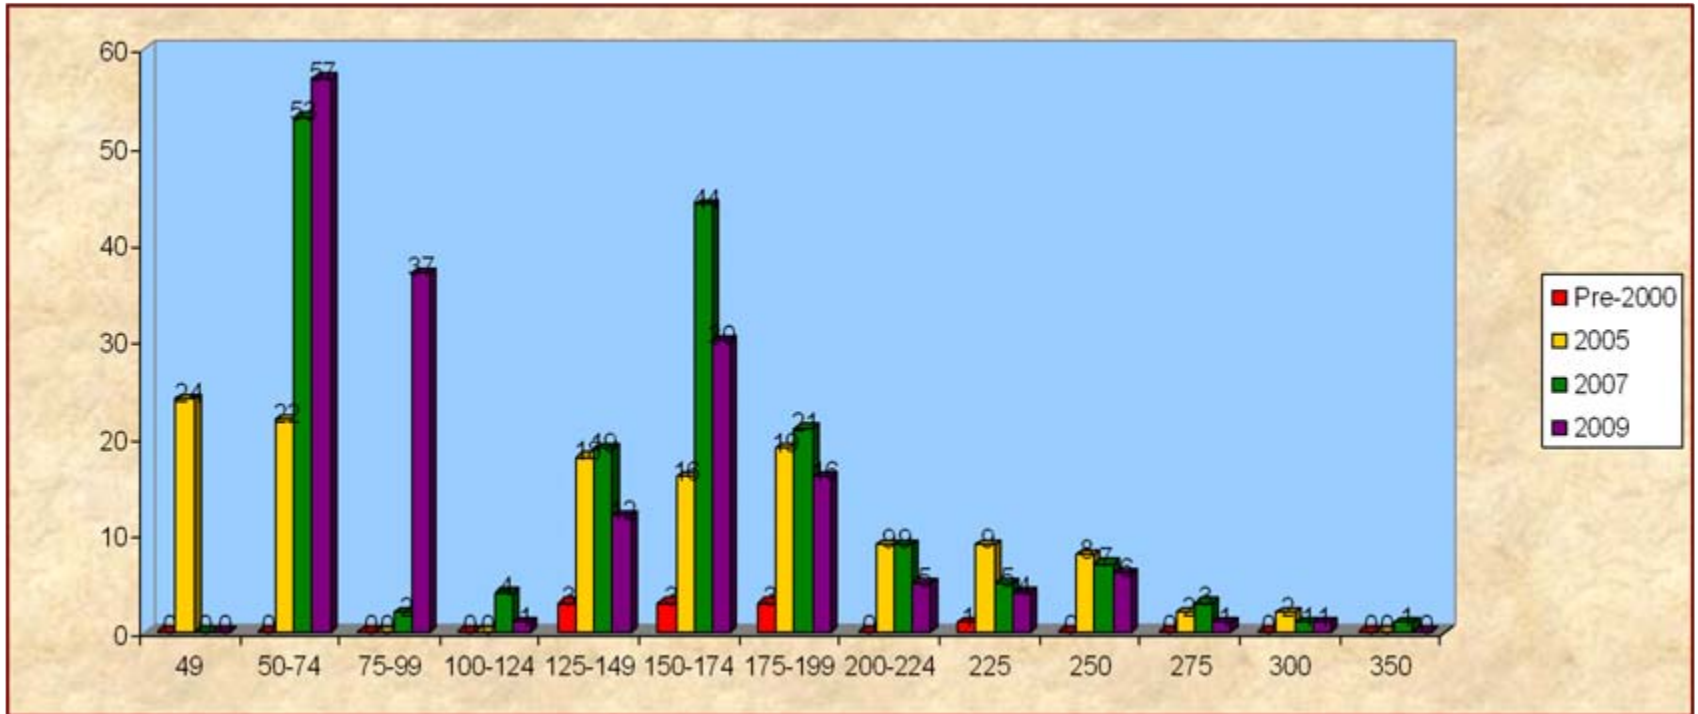
Size Class Catch

Pre-Project vs. 5, 7 & 9-Year Survey

- Pre-project trout sizes ranged between 5 and 9 inches.
- Post-project trout sizes ranged from young-of-the-year to 14 inches.

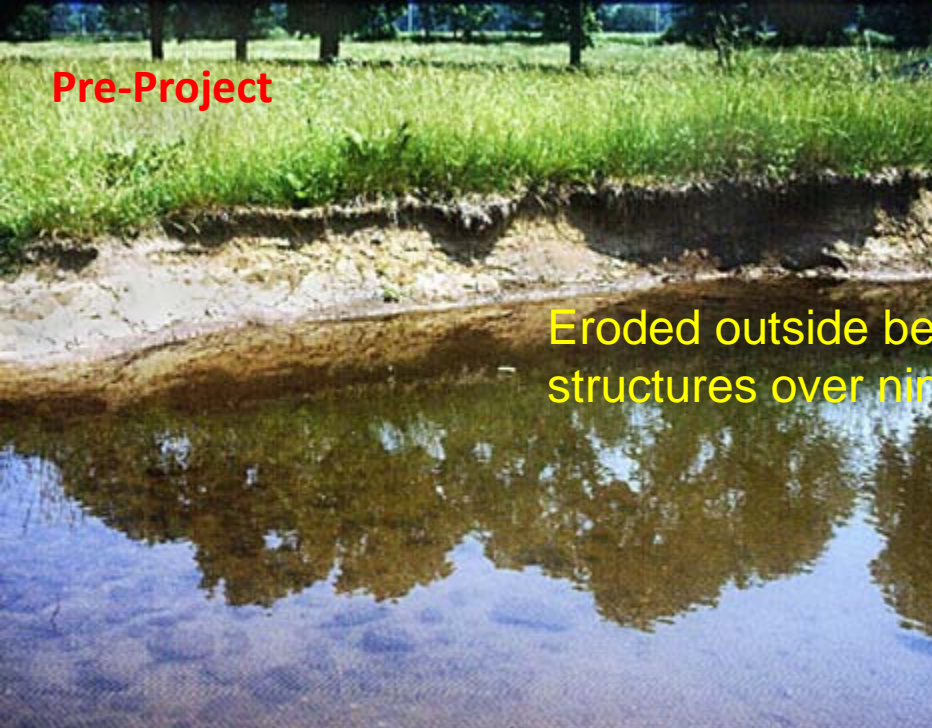
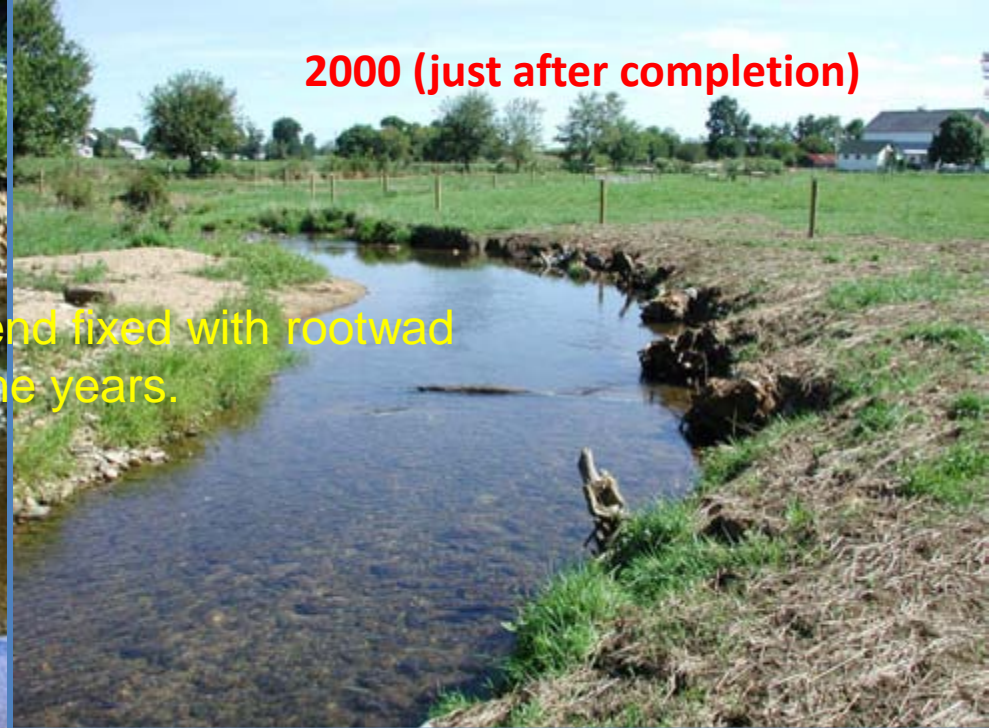
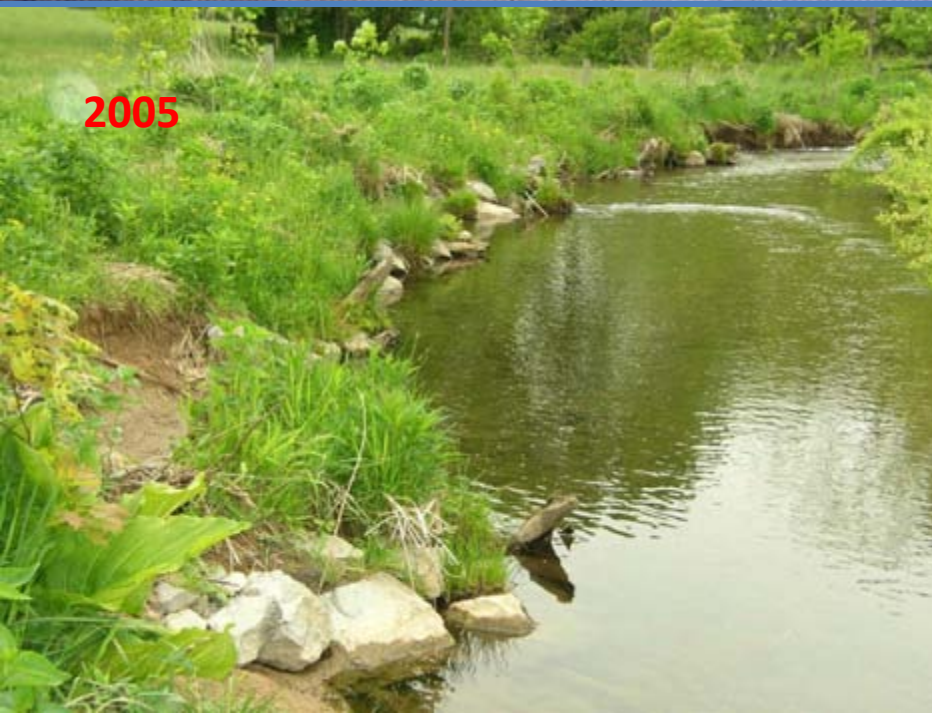
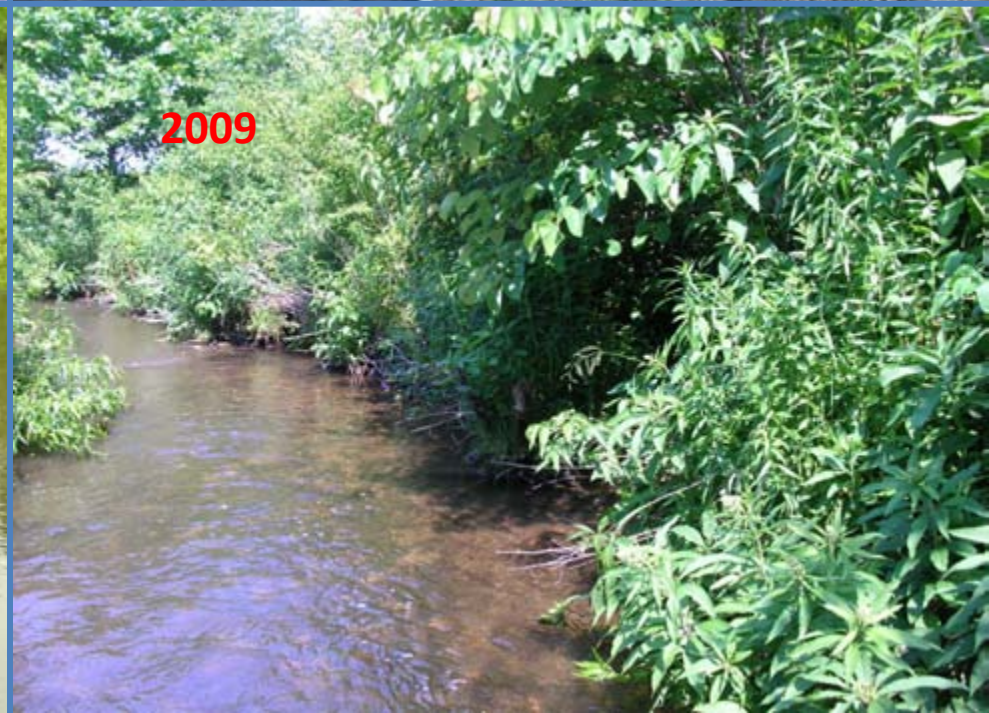
Pre-Project

Eroded outside bend fixed with rootwad structures over nine years.

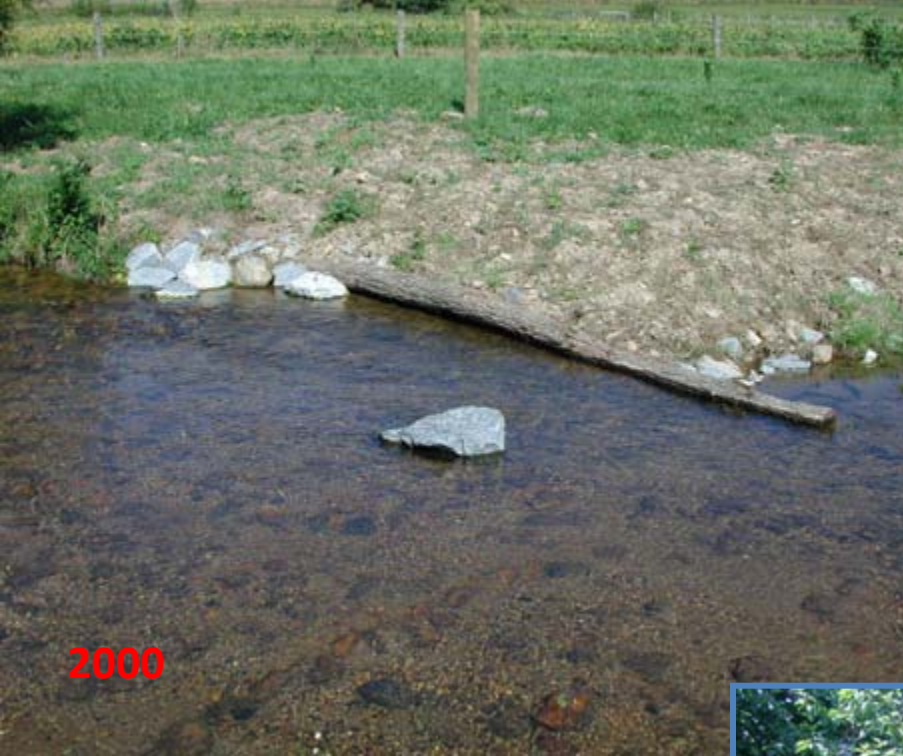
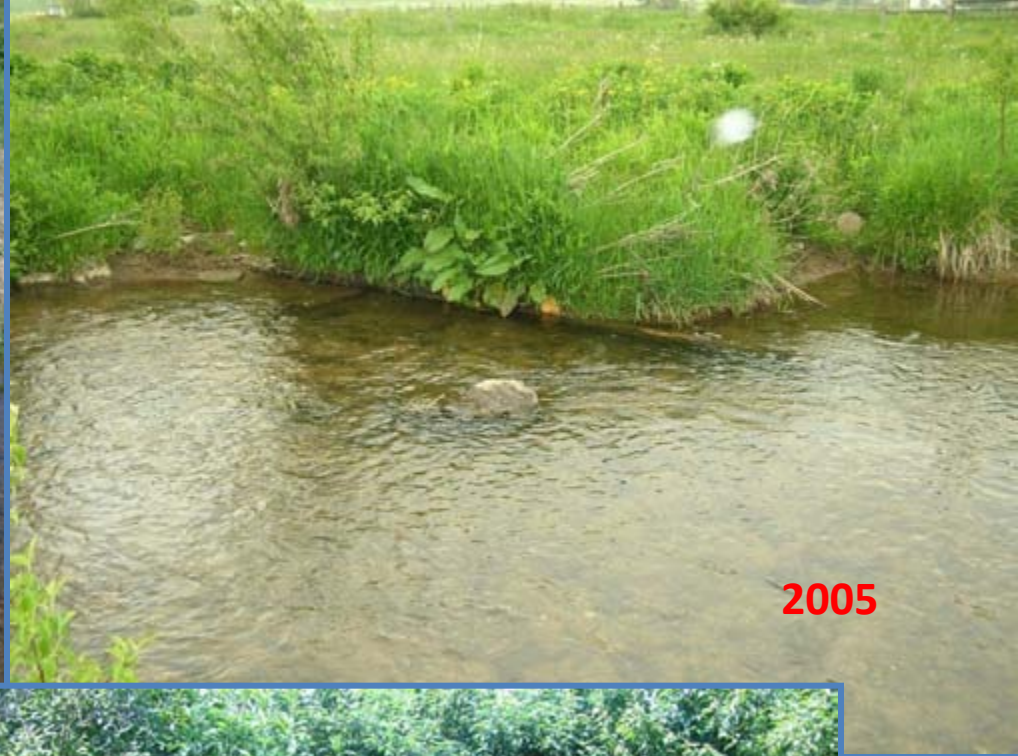
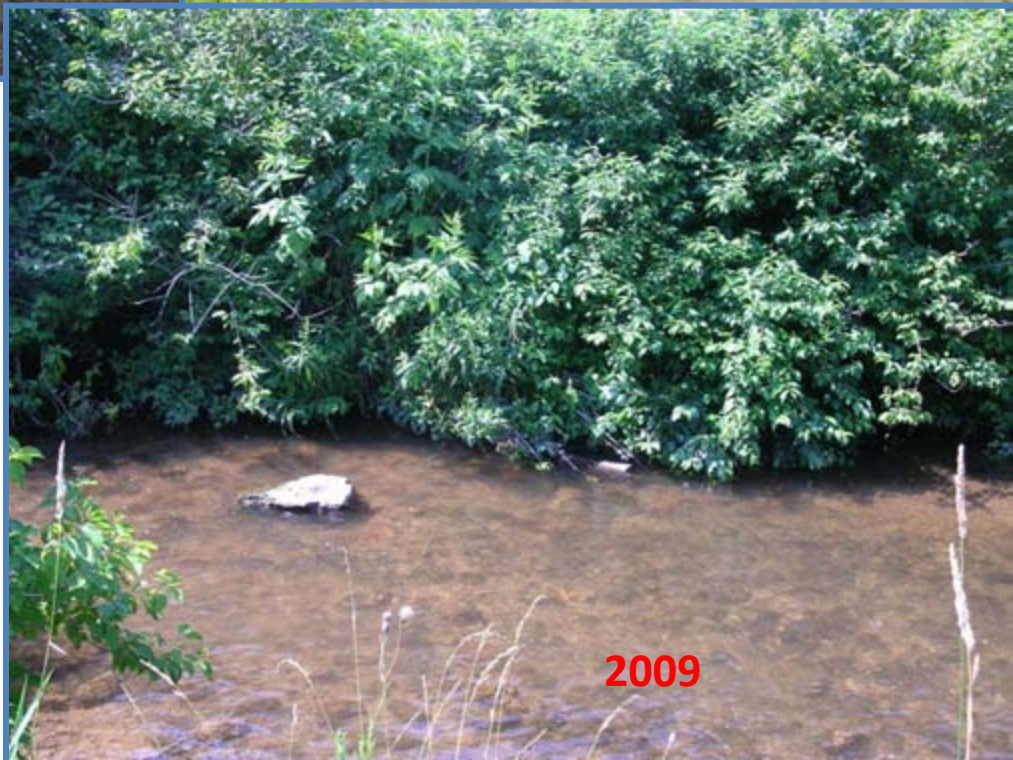
Stacked deflector structure over nine years.
