CANAL IN THE MOUNTAINS

The Juniata Main Line Canal
in the Lewistown Narrows

Pennsylvania Department
of Transportation

Scott D. Heberling
Heberling Associates, Inc.

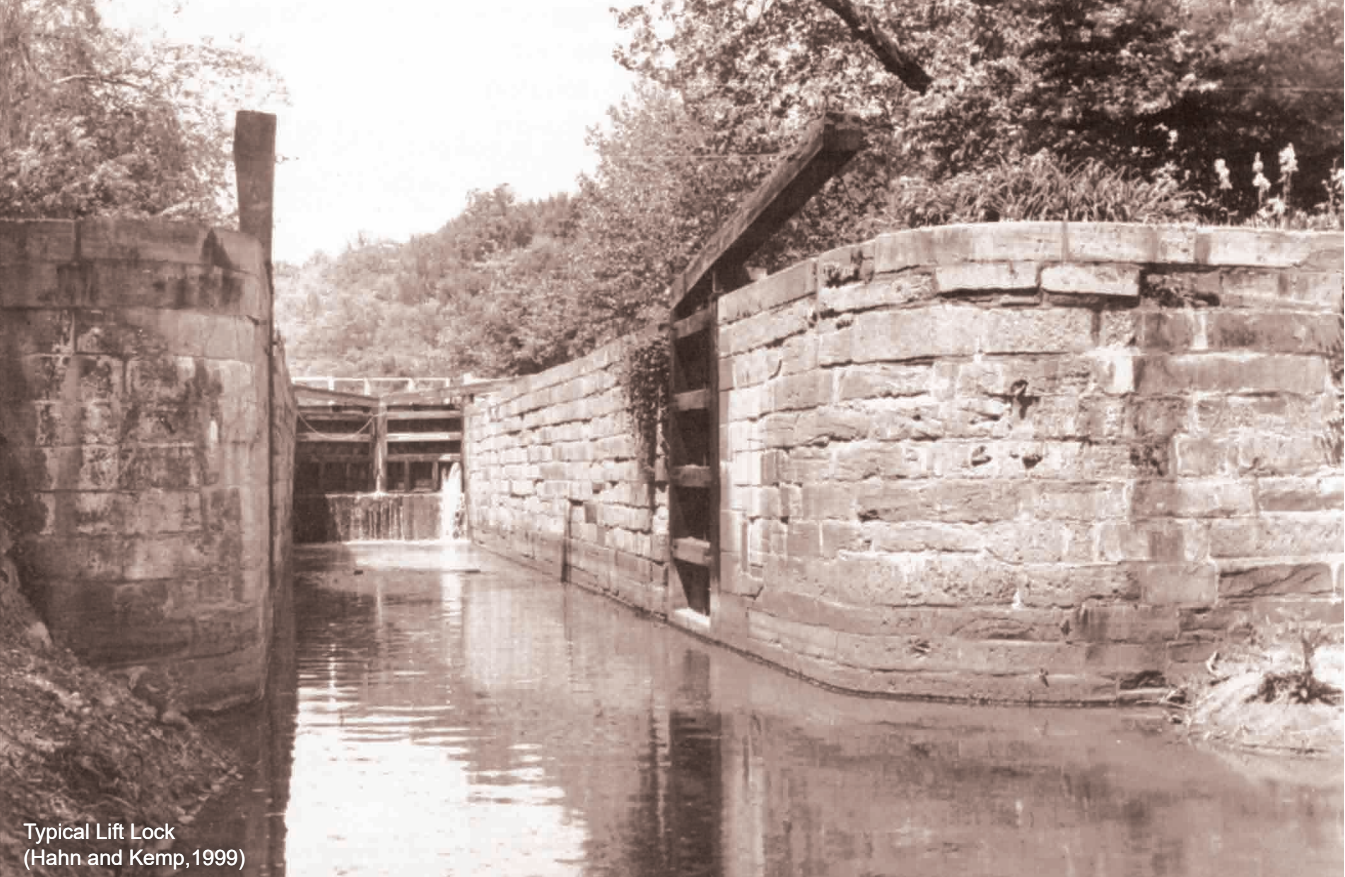
Typical Lift Lock
(Hahn and Kemp, 1999)

All lift lock chambers on the Juniata Division were 15 feet wide and 90 feet long, with a four-foot wide spillway along the uphill side. In contrast to the Eastern and Western Divisions, where the locks were constructed of cut stone laid in mortar, most of the locks on the Juniata Division were built of dry-laid “rubble stone” faced with watertight planking; 77 were of this type, while seven (including those in the Narrows) were of rubble stone laid in mortar, and four were of cut stone. On the Lower Juniata Division, there were 33 lift locks, two outlet locks, three guard locks, and one weigh lock; other structures included 42 road bridges, 37 farm bridges, seven towpath bridges, three foot bridges, 18 aqueducts, five river dams, 46 culverts, and 27 waste-weirs. All of these structures were built according to standard design specifications. A single quarry near the village of Mexico produced most of the building stone used on the Juniata Division.

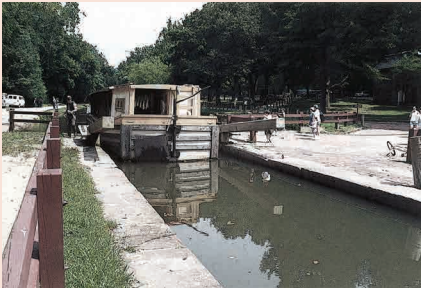
1.

With the upper gates open and the chamber filled with water, a boat headed downstream enters the upper end of the lock.

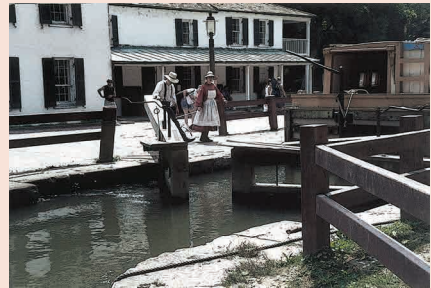
2.

When the boat is completely inside the lock chamber, the lock-keeper closes the upper gates.

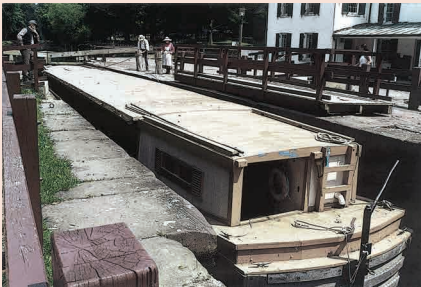
5.

As the water level falls, the boat is slowly lowered.

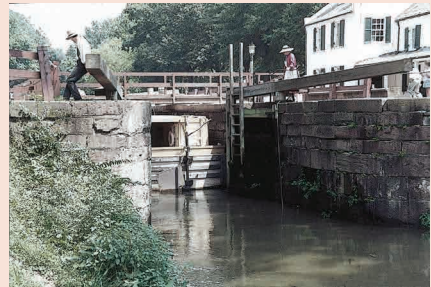
6.

The lower gates are opened after the water level on both sides is equalized.

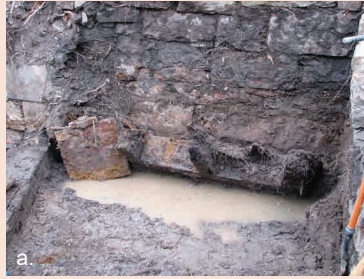
Excavation of Lock No. 13 at the Lewistown Narrows Canal Park uncovered the base of a lock gate with two cast-iron valves still in place (a). One of the valves was restored by professional conservators. Here the valve is shown before (b), during (c) and after (d) treatment.

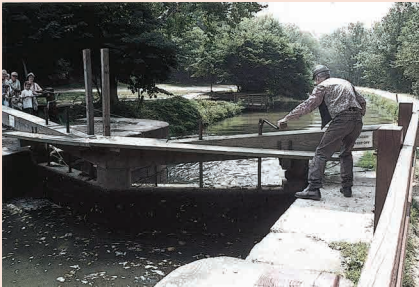
3.

The lock-keeper opens the paddle valves in the lower gates...

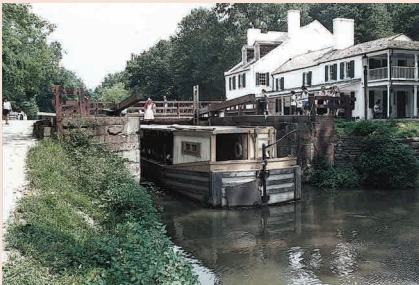
7.

The boat emerges from the downstream end of the lock...

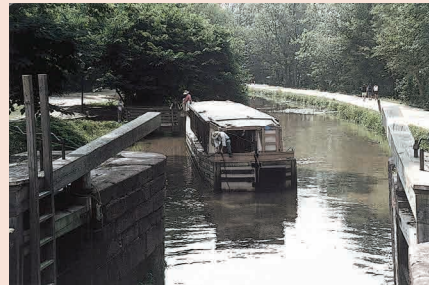
8.

...and continues on its way. The process is reversed for boats heading upstream.

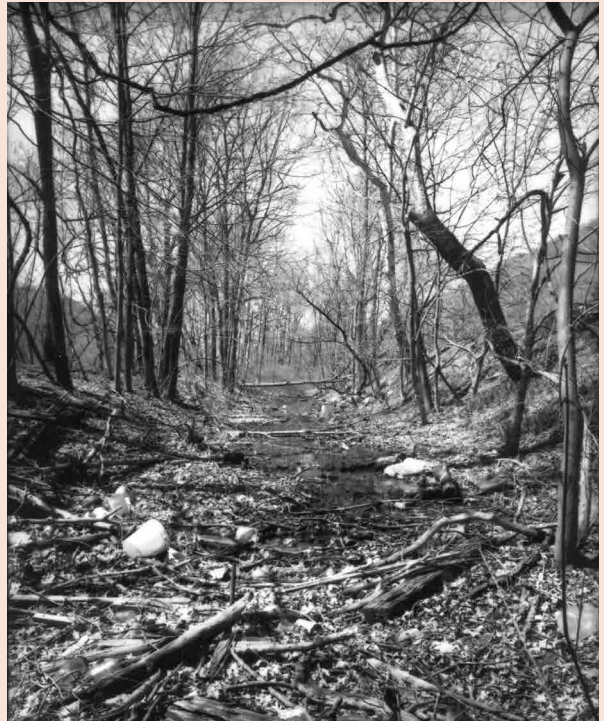
Well-preserved section of canal prism and towpath, 2000

The condition of the canal prism and towpath varied greatly in different areas. Several long sections had been completely filled in during highway widening in the 1930s or had been graded by private landowners. Others had been badly damaged by past flooding that had eroded the towpath and filled the prism with sediment, but much of the canal was still in excellent condition. Project historians battled snakes, insects, and dense underbrush while carefully mapping and photographing each canal section.

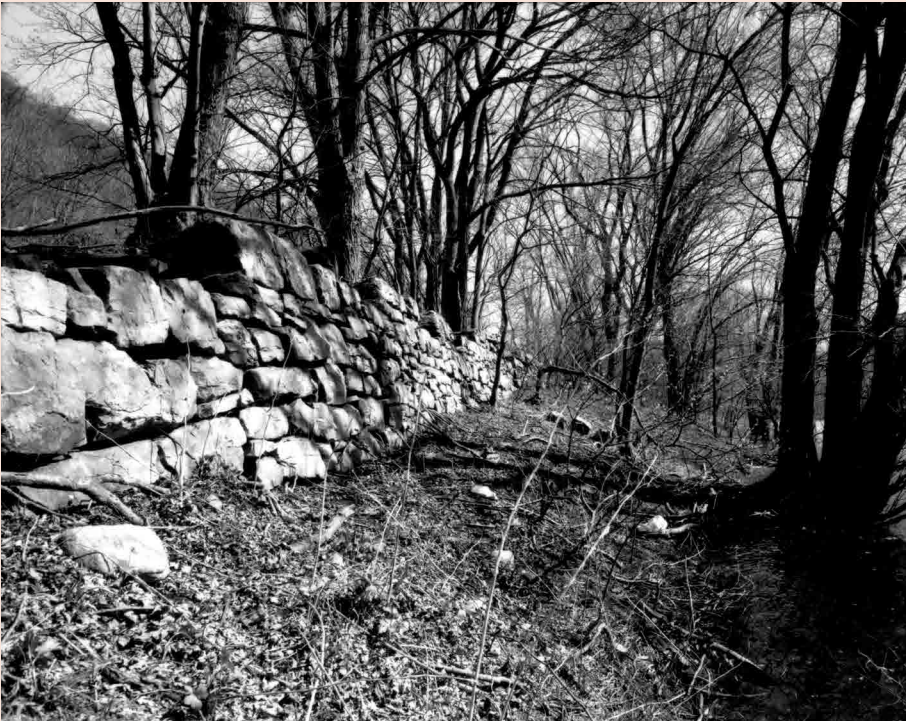
Representative section
of river wall, 2000

The canal's location adjacent to the river exposed it to destructive flood waters and ice jams which swept through the Narrows each spring. The engineers took extraordinary measures to protect the canal from swift river currents. The towpath and berm banks were unusually high, originally built to be 18 feet above low water and 25 feet above the river bottom. The engineers also built a massive river wall, 2-15 feet high depending on the terrain, along the outer face of the towpath bank.

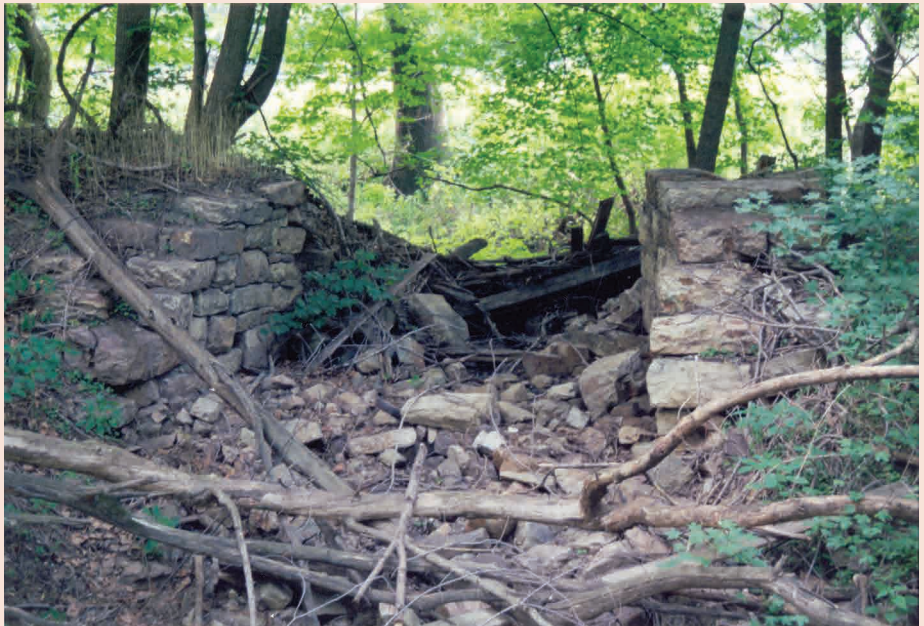
Remains of Waste-weir No.11 at Roaring Run, 1997

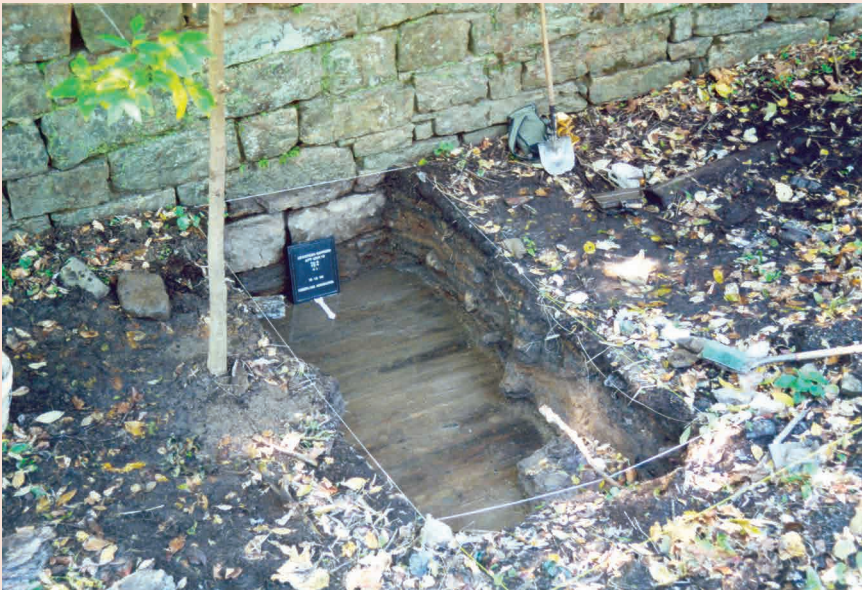
Archaeology exposed the original wood plank floor of the lock

Lift Lock No. 13 was located at Macedonia Run, near the east end of the Narrows. Although portions of the walls had collapsed and the chamber was filled with sediment and highway fill, archaeology revealed that the original wood floor and other structural elements were remarkably intact. This lock eventually became the centerpiece of the Lewistown Narrows Canal Park.

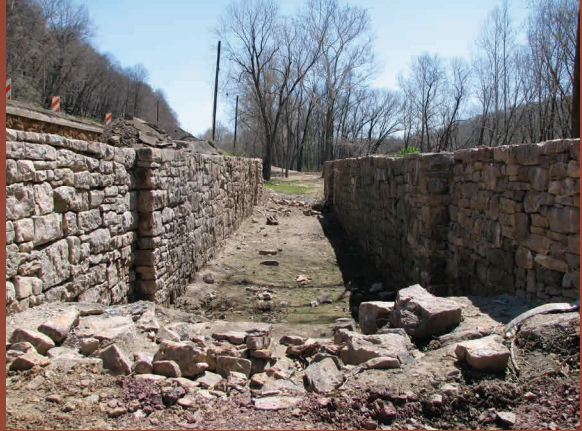
Restored Lock No. 13, April 2008

The centerpiece of the Lewistown Narrows Canal Park is Lift Lock No. 13, one of three locks in the Narrows. Prior to the project, the lock was filled with up to five feet of silt and rubble, and the north wall and both ends had collapsed. However the south wall was mostly intact, and archaeology revealed that the original wood floor and substructure were still in excellent condition. Following archaeological excavation and detailed documentation of the lock, skilled stone masons repaired and reconstructed the chamber walls, following the original 1820s design plans and specifications. A layer of sand was placed in the lock chamber to protect the wood floor and gate remnants which were left in place.
