ART SCHOOL ROAD BRIDGES REPLACEMENT PROJECT

QIONG LIU– DECEMBER 2023

Art School Road bridge replacement over Branch of Pickering Creek

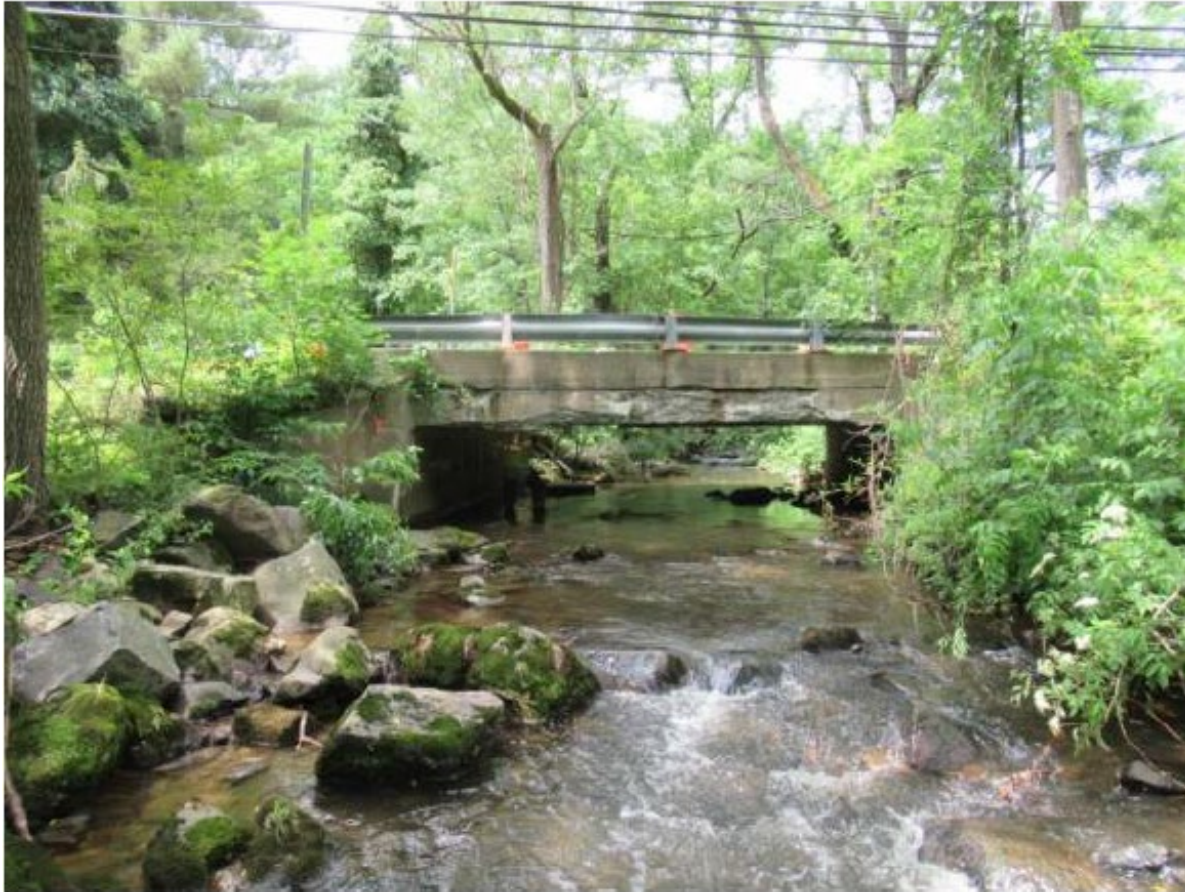
Existing Bridge #1:

- Concrete Encased Steel I-Beam
- 22 feet long, two lanes with no shoulder
- Built in 1920

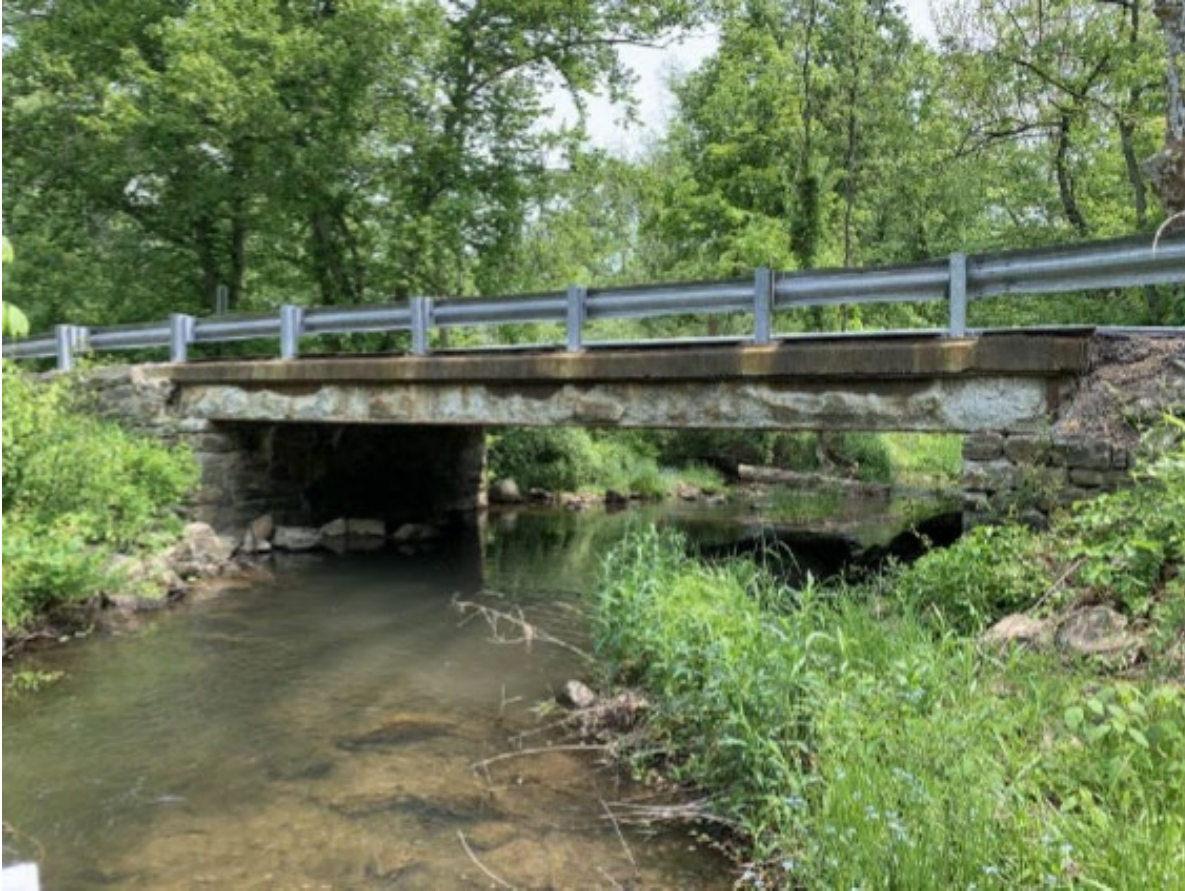
Existing Bridge #2:

- Concrete Encased Steel I-Beam
- 30 feet long, two lanes with no shoulder
- Built in 1920

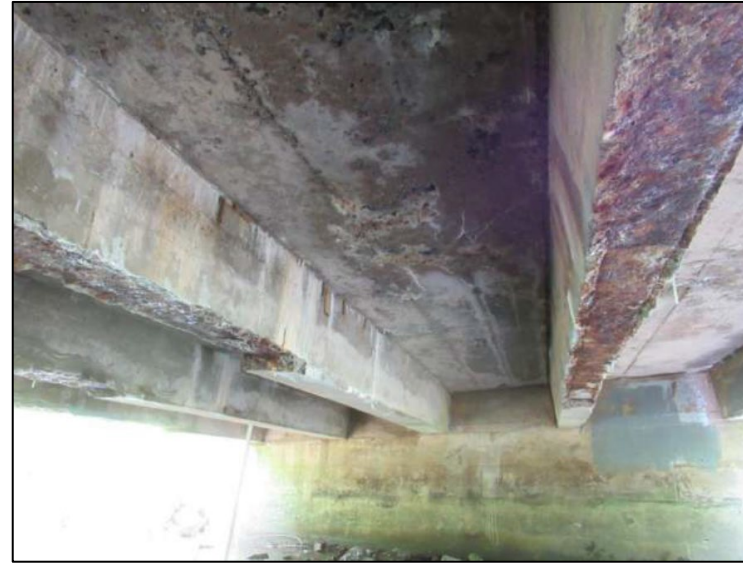
Bridge #1

The most recent inspection report detailed the deteriorated condition of the structure as listed below:

- Superstructure
- Bridge deck
- Substructure
